WHITECLIFFE ENTRANCE GATEWAYS

Design Proposal

July 2020

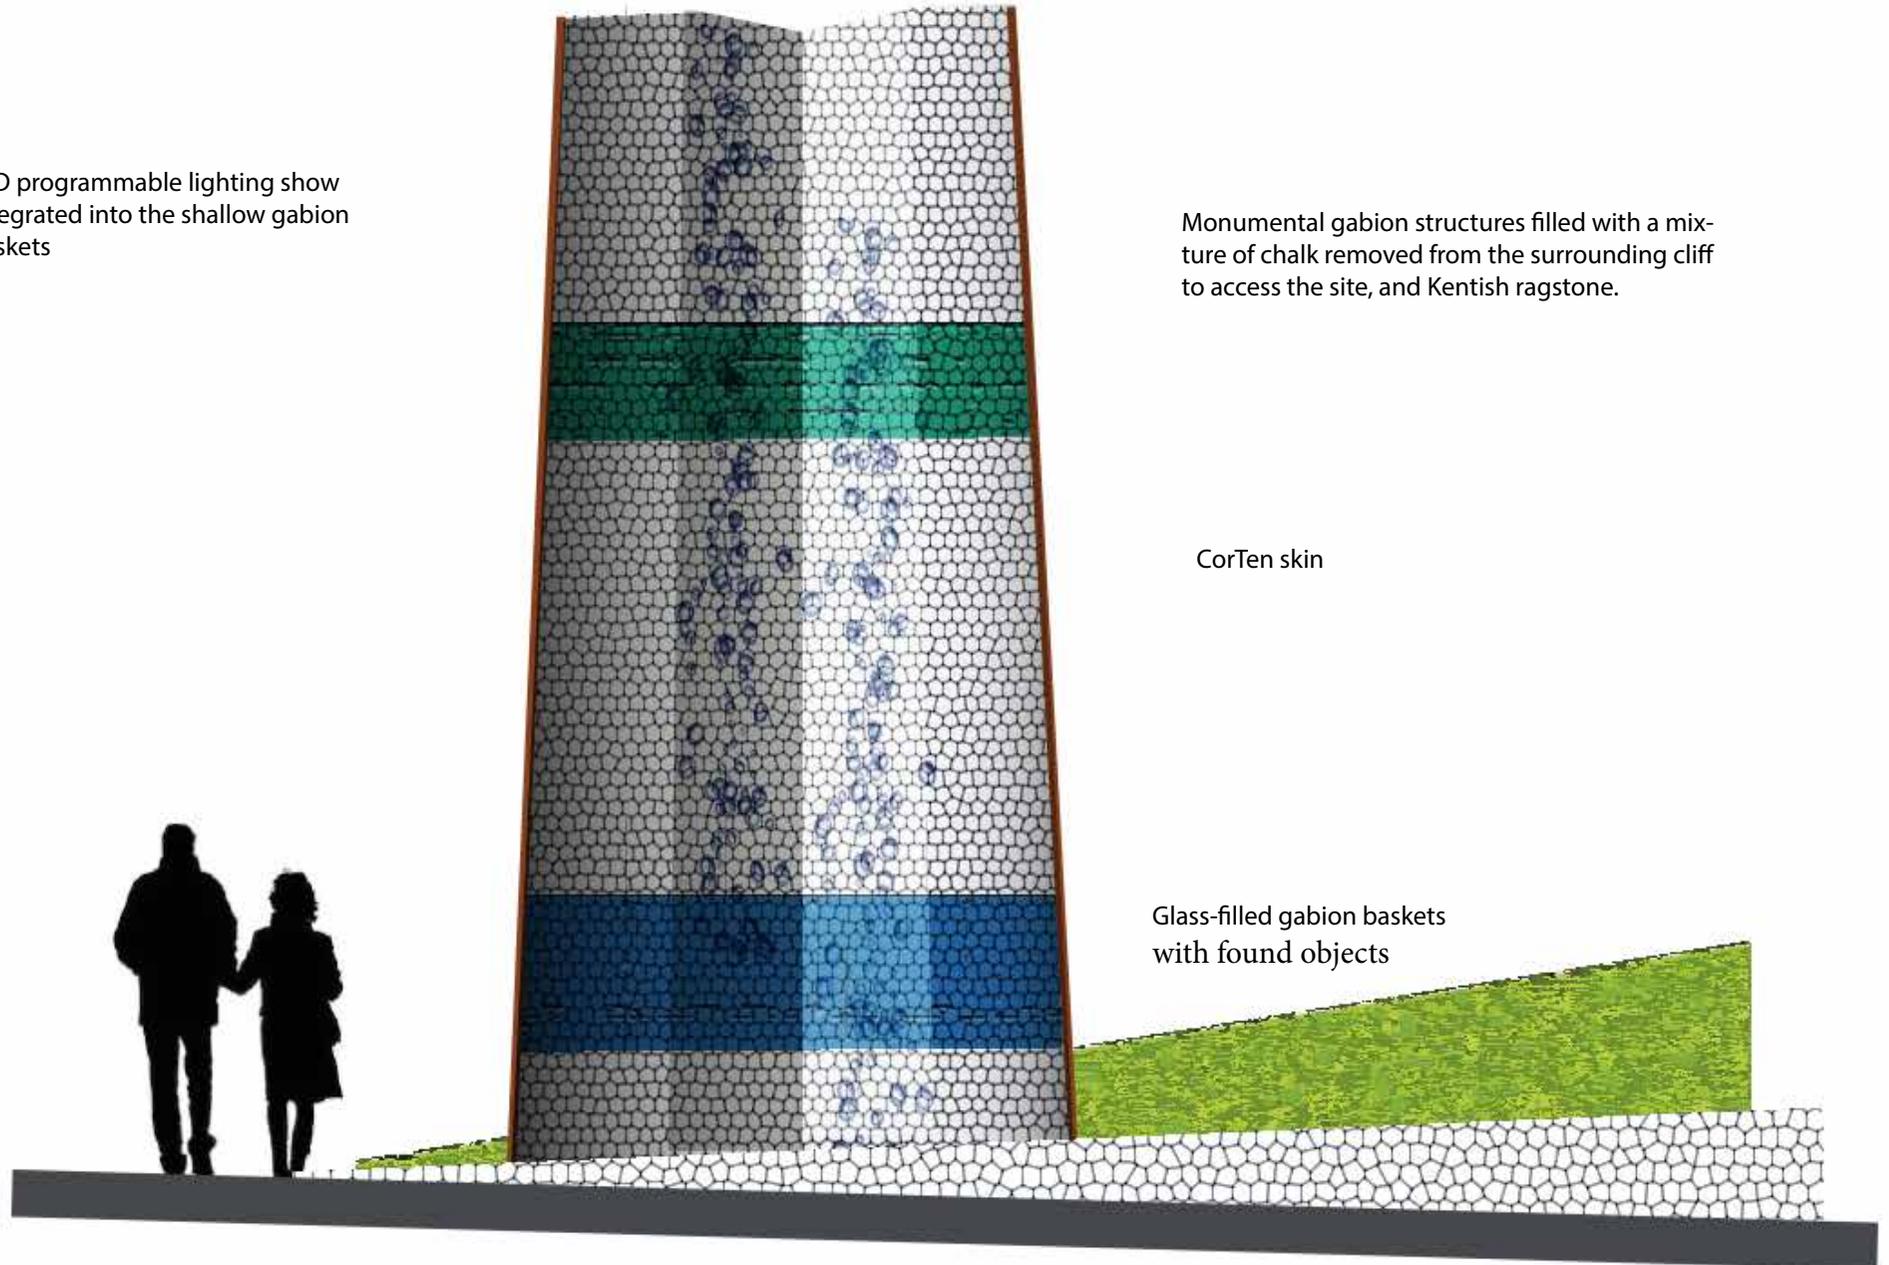
Castle Place Entrance

solar panels to top of structure?

LED programmable lighting show integrated into the shallow gabion baskets

Monumental gabion structures filled with a mixture of chalk removed from the surrounding cliff to access the site, and Kentish ragstone.

CorTen skin

Glass-filled gabion baskets with found objects

To animate and dramatise the structure I have proposed a fully programmable LED lighting show, built into the gabions and surrounding Corten skin structure. This can be programmed to present differing light shows for selected calendar events. This would be achieved using architectural IP67 rated rgb LEDs and a DMX control with chronological clock.

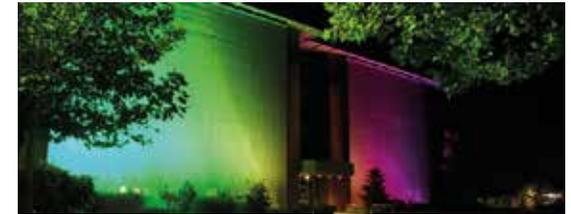
LED RGB node strings

Pharos Controller for DMX programming

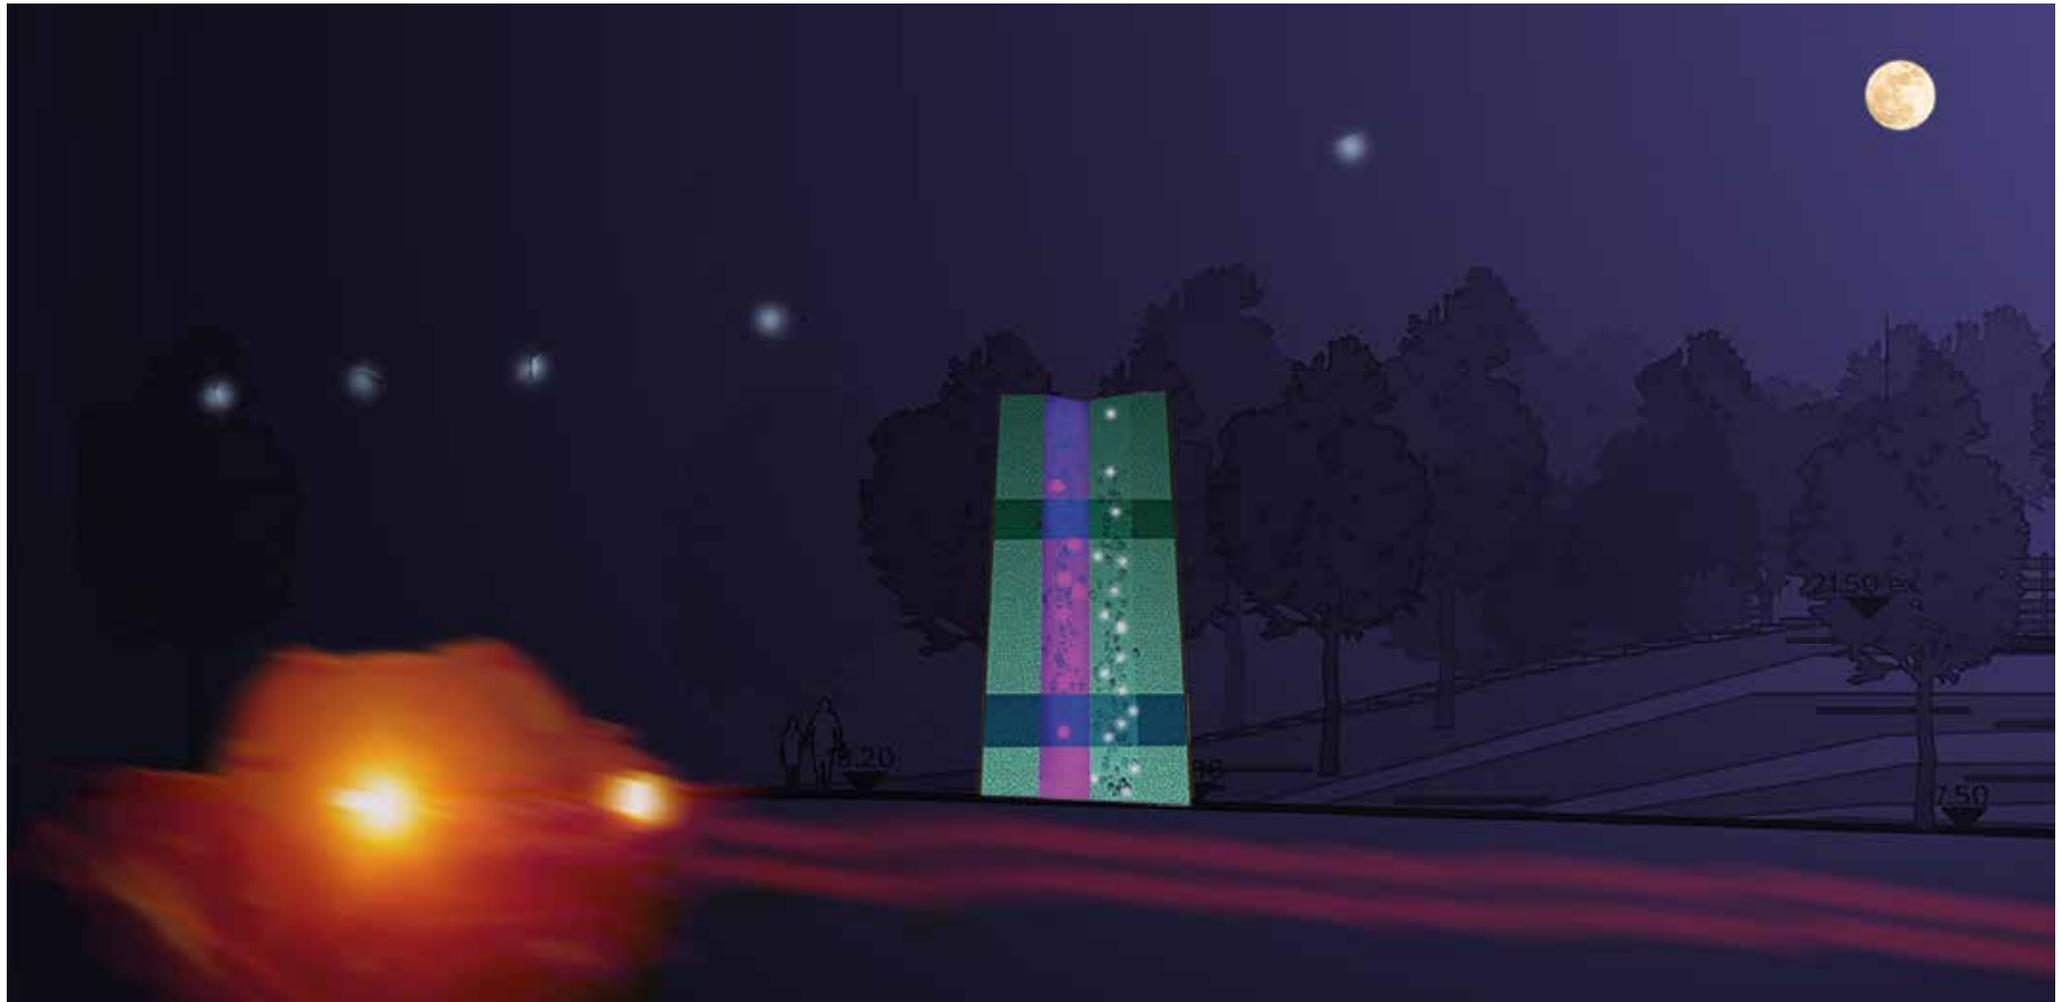
Castle Place Entrance

Elevation

Plan

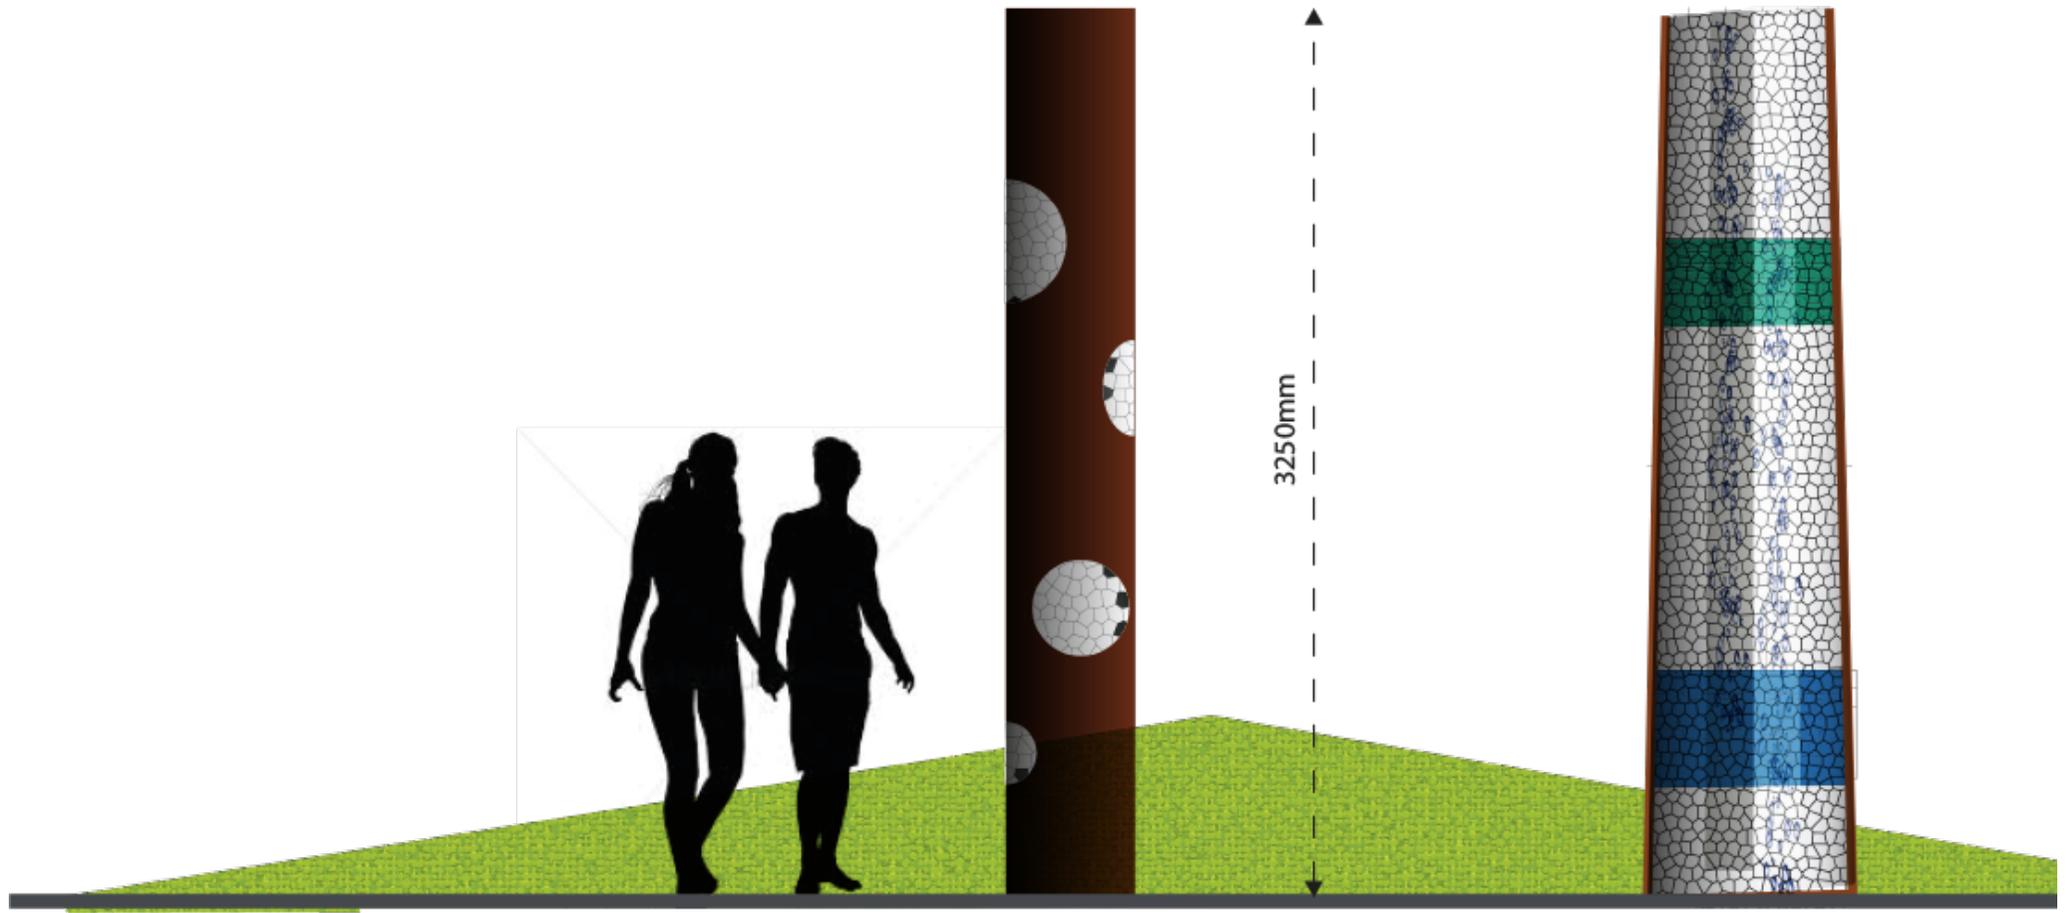
Southfleet road Entrance

Elevation A

475mm
